## KTI-Project: LIDT and Degradation Testing for Industrial Applications

## The RhySearch LIDT Testing Facility at the NTB Buchs

## An LIDT Measurement Process: S-on-1

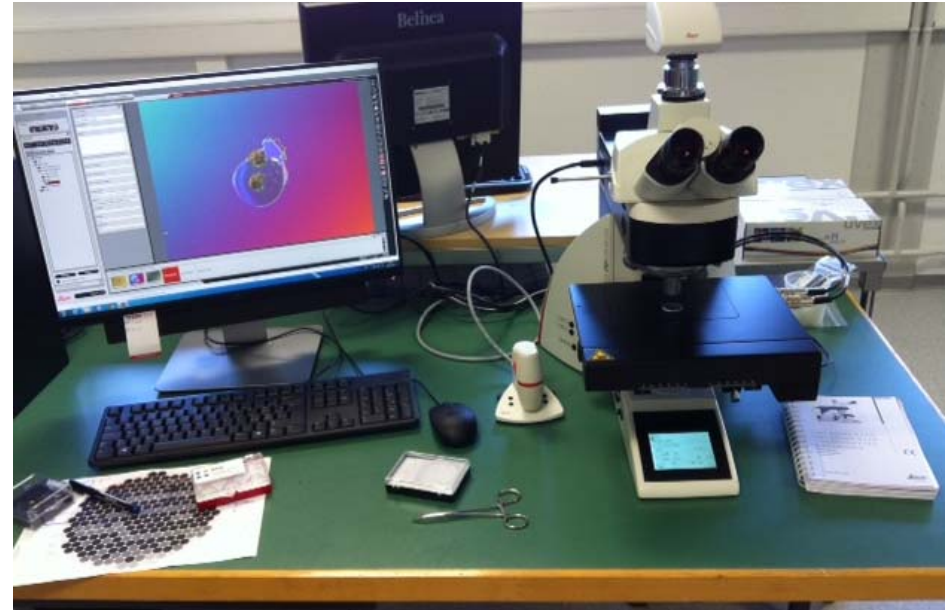
- **Post LIDT Testing damage verification using a Nomarski DIC Microscope (100x)**
  - **Deviations are incorporated into the measured results**

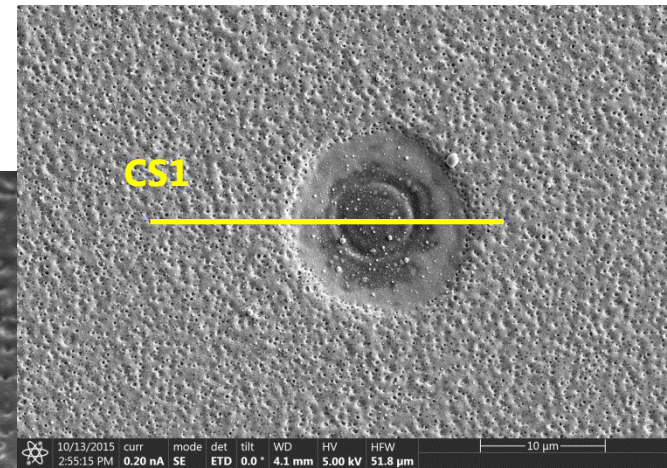
# SEM/FIB-Untersuchung: Spot 3

CS1 – Zentrum des Beschusses:

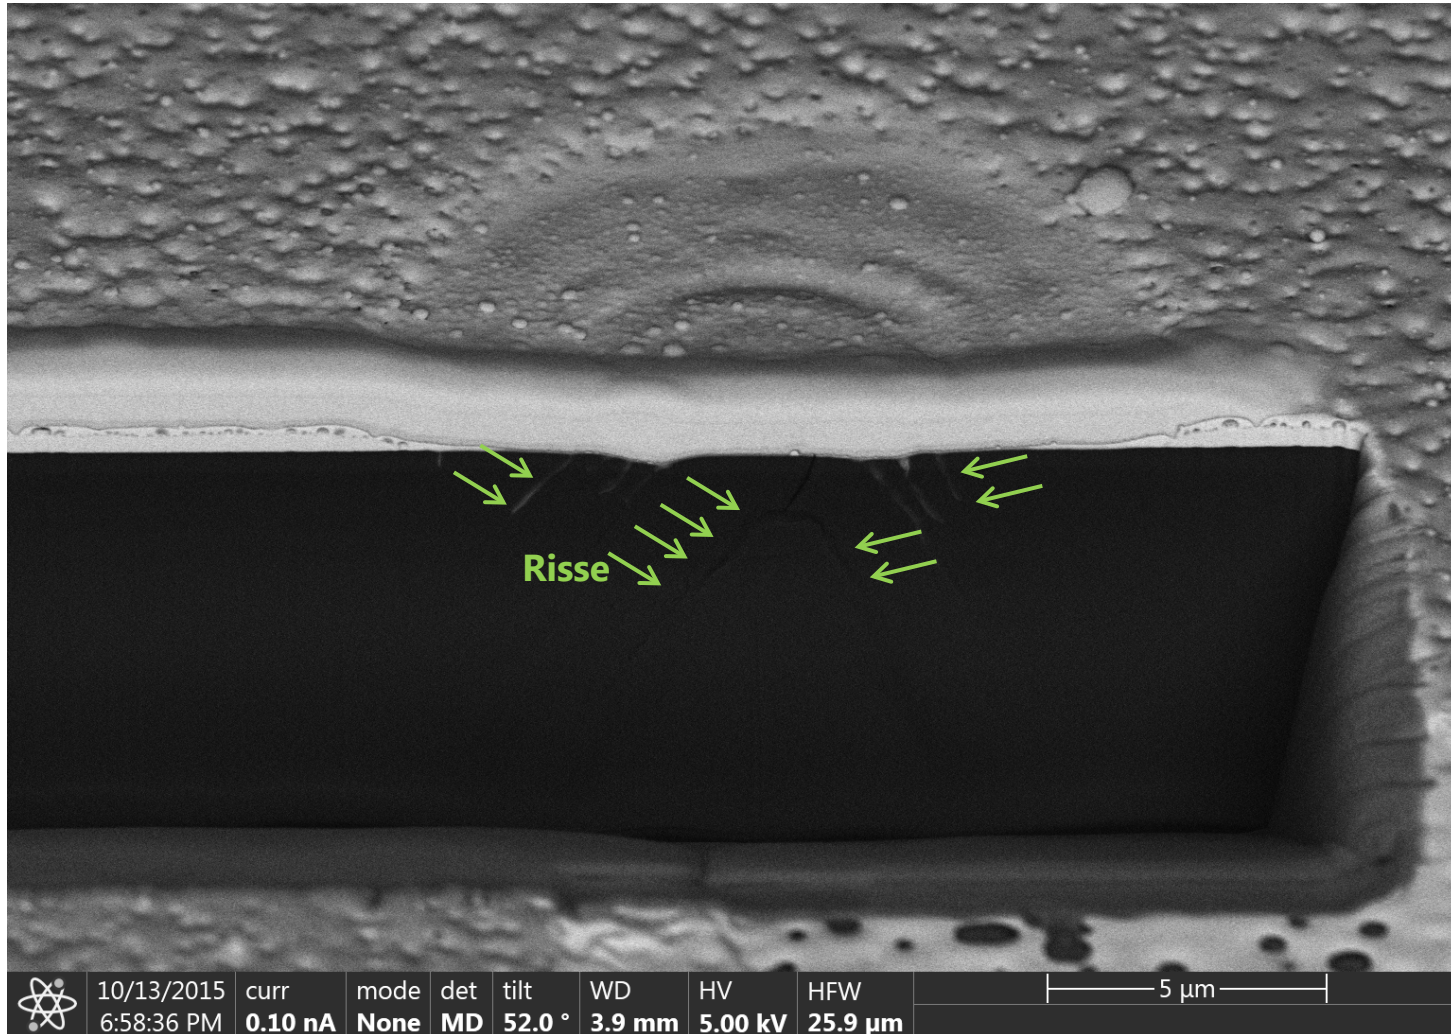
# SEM/FIB-Untersuchung: Spot 3

CS1 – Zentrum des Beschusses:
